Riveted Railroad Bridge under Dynamic Load

Abstract:

Keywords: Railway bridge, Fatigue, Damage progress, Brittle failure

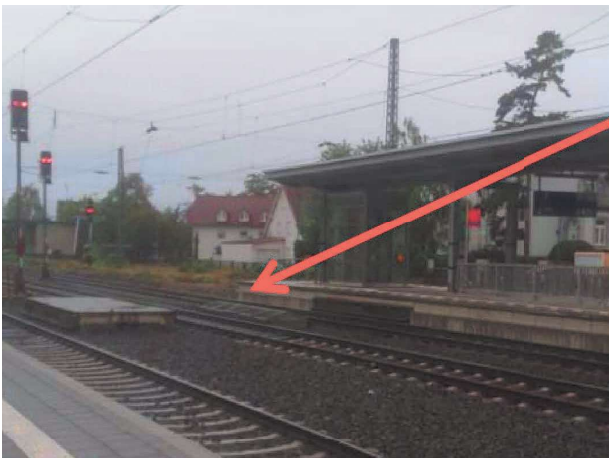
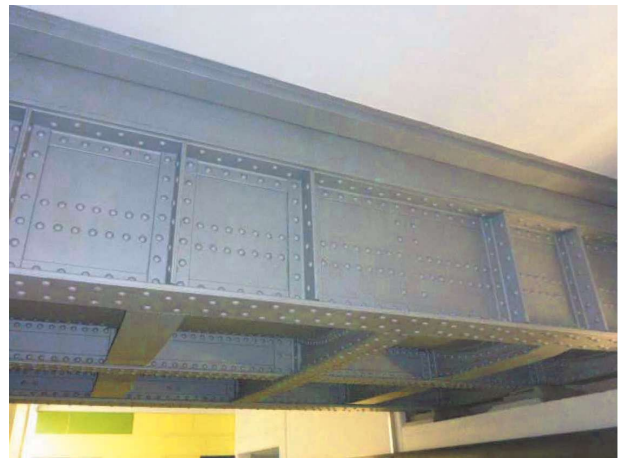
Figure 1: Bridge Gau-Algesheim before dismantling

(a) View from above

(b) View from below

The historic bridge from Gau-Algesheim station, used for the experimental investigation, was constructed in 1903 and remained in service for over a century before being dismantled in 2020. Gau-Algesheim is located on the railway line between Mainz and Cologne, one of the busiest railway corridors in Germany. The underpass served as an access for passengers to reach the various platforms (Figure 1).

Over the decades, the bridge carried both heavy freight trains and high-speed passenger trains. The structure is a half-through construction made of casted iron. It consists entirely of angle sections and flat plates, some of which are riveted together in multiple layers. The bridge spans 4.8 meters and has a width of 3.0 meters. The curved steel plates are also riveted to the transverse connection beams. In its operational state, ballast, sleepers, and rails were placed directly on top of the curved steel plates [4].

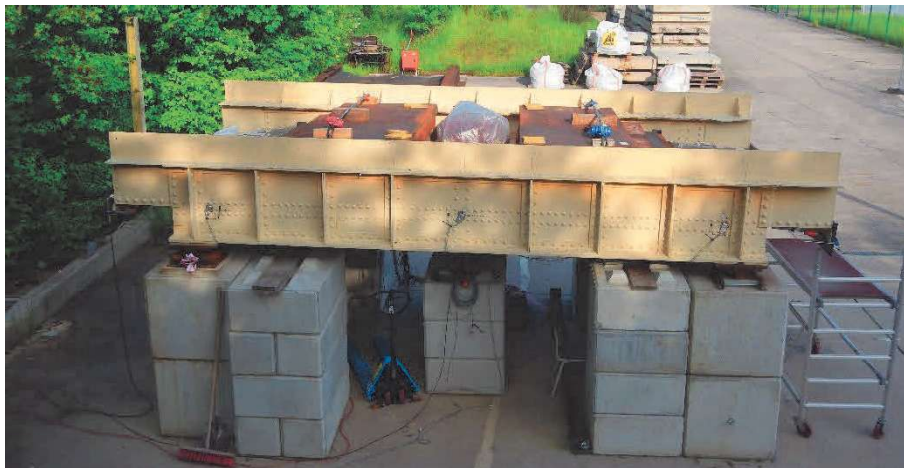
Figure 2: Test setup of riveted bridge

The test facility shown in Figure 2, located at the University of the Bundeswehr Munich, enables both static and dynamic investigations on full-scale bridge structures under controlled laboratory conditions.

For static testing, vertical loads can be applied precisely at mid-span, allowing for accurate measurement of bridge deflection and subsequent determination of global stiffness.

Dynamic testing is performed using a combination of static ballast and a centrally positioned unbalanced vibration exciter, simulating the dynamic effects of passing trains. To match the structural response to realistic conditions, steel plates are added (Figure 2), reducing the natural frequency of the bridge from approximately 40 Hz to 12 Hz. This adjustment is essential, as the vibration exciter operates at a maximum rotational speed of 1000 rpm [5]. The excitation frequency can be continuously adjusted to match the bridge's natural frequency. When resonance is achieved, the vibration amplitude reaches its maximum [6]. The excitation force can be controlled by varying the unbalanced mass of the exciter. At resonance, vibration amplitudes equivalent to those induced by real train crossings can be generated with minimal energy input. The setup offers an optimal configuration, providing excellent accessibility, flexible load application, and well-defined support conditions, ensuring reproducible and representative test results.

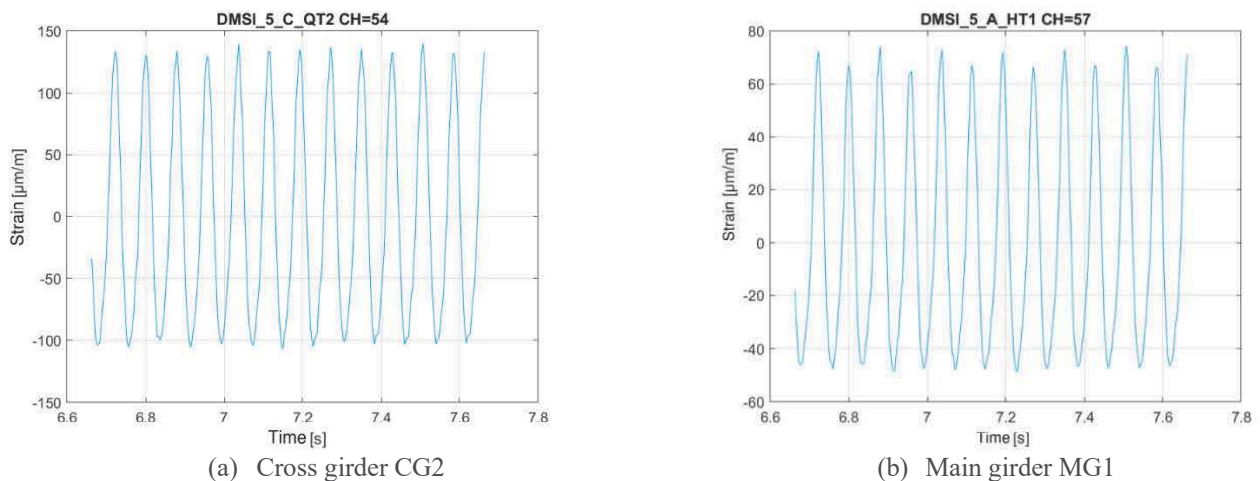
Figure 3: Strain measurement during dynamic test

Cross girder 2 (CG2)

$$\Delta\varepsilon_{CG2} = 140 \mu\text{m/m} - (-103 \mu\text{m/m}) = 243 \mu\text{m/m} \quad (1.1)$$

$$\Delta\sigma_{CG2} = \Delta\varepsilon_{CG2} \cdot E = 243 \mu\text{m/m} \cdot 210.000 \text{ MPa} = 51 \text{ MPa} \quad (1.2)$$

Main girder 1 (MG1)

$$\Delta\varepsilon_{MG1} = 73 \mu\text{m/m} - (-47 \mu\text{m/m}) = 120 \mu\text{m/m} \quad (2.1)$$

$$\Delta\sigma_{MG1} = \Delta\varepsilon_{MG1} \cdot E = 120 \mu\text{m/m} \cdot 210.000 \text{ MPa} = 25,2 \text{ MPa} \quad (2.2)$$

A total of five million load cycles were applied, corresponding to the fatigue strength threshold as defined in [8]. During the test, a vertical deflection amplitude of 3.1 mm was measured at mid-span. The experimentally induced strain levels were recorded using strain gauges and confirmed by analytical calculations. As shown in Figure 3 and determined from equations (1.1) and (1.2), the stress amplitude at the central cross girder reached 51.0 MPa. At the longitudinal main girder, which runs along the length of the bridge, a stress amplitude of 25.2 MPa was observed, as illustrated in Figure 3 and derived from equations (2.1) and (2.2). These results demonstrate that the test conditions effectively replicate realistic dynamic loading scenarios and enable the evaluation of the fatigue behavior of historic riveted bridge structures.

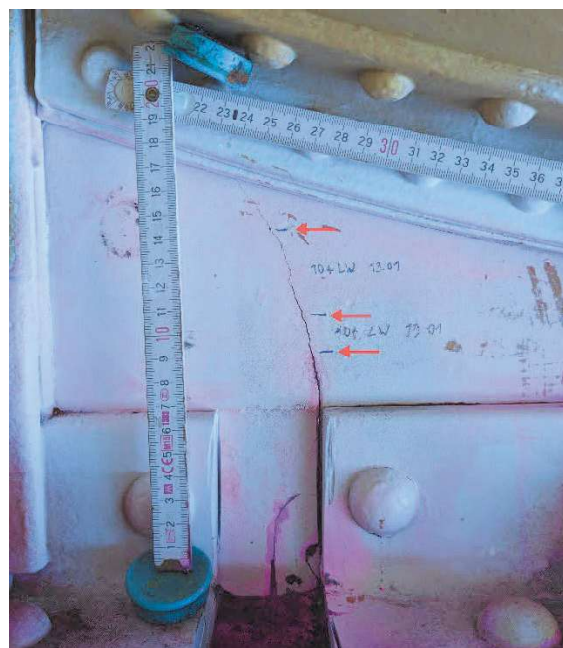
Figure 4: Crack caused by dynamic load

Following these interventions, crack initiation was observed for the first time. The crack exhibited slow and continuous growth without any abrupt failure, indicating ductile fracture behavior. The progression of the crack was documented at intervals of 10,000 load cycles, marked by red arrows in Figure 4. The increasing distance between consecutive arrows indicated an accelerating crack growth rate. The crack propagated toward a rivet hole but did not lead to brittle failure. These experiments provide valuable insights into the fatigue behavior and failure mechanisms of historic riveted bridge structures. Even under artificially induced damage, the tested components did not exhibit sudden or brittle failure. The historic wrought iron material showed a ductile response under realistic load conditions, suggesting that riveted structures of this type are not inherently prone to critical failure.

In the first phase, two rivets were removed at critical locations. One of the resulting rivet holes was closed using a preloaded bolt to simulate thermal prestress, which is relevant to fatigue behavior [7]. Furthermore, semicircular notches with diameters of 0.9 mm and 2.3 mm were milled into the bottom plate of the central cross girder, which is composed of angles and profile sections (see Figure 4).

In the third phase, a more severe level of artificial damage was introduced. Due to the segmented construction of the girders—consisting of individual angles and plates—earlier damage scenarios had affected only portions of the cross-section. In this phase, both the lower flange plate and the associated angle (forming the lower chord) of the central cross girder were removed. Additionally, a sharp notch was cut into the web plate to create a pronounced stress concentration (see Figure 4).

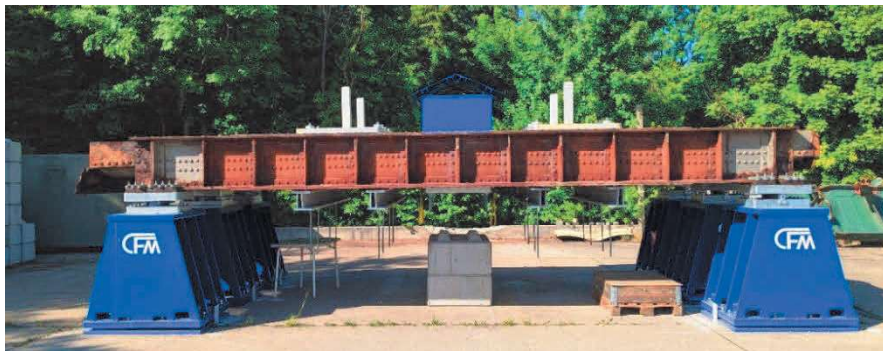
Figure 5: Test setup for bridge Andernach

A more powerful vibration exciter has been integrated into the system, allowing for higher excitation amplitudes and testing of stiffer bridge structures. A riveted railway bridge from Andernach, featuring a span of 6.8 m, has already been mounted in the new setup (Figure 5). The structural condition of this bridge is significantly more deteriorated compared to the Gau-Algesheim bridge; loose rivets, weld seams, and visible cracks are present. Another bridge from Andernach with a 3.6 m span is planned for subsequent testing. The experimental objectives remain consistent: to investigate fatigue behavior and failure mechanisms of historic riveted bridge structures under realistic conditions.
