Effect of a process interruption on the mechanical properties of AlSi10Mg components produced by laser powder bed fusion (PBF-LB/M)

Abstract

Keywords Powder bed fusion of metal with laser beam (PBF-LB/M) · AlSi10Mg · Process interruption · Additive manufacturing (AM) · Mechanical properties

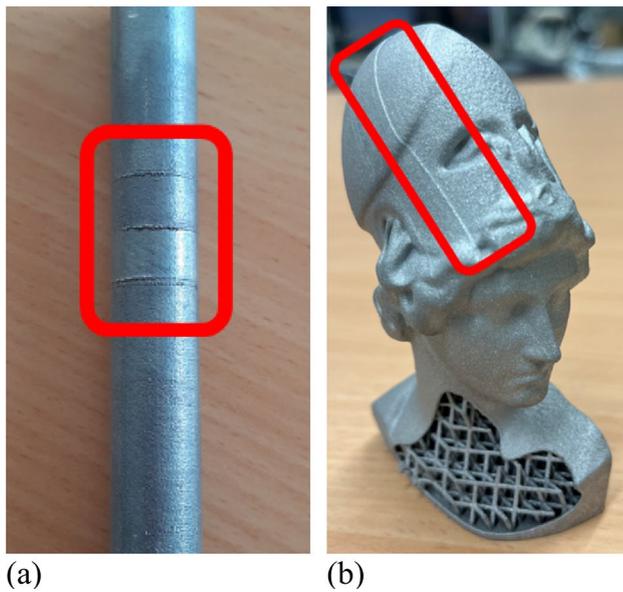
Fig. 1 Layer shift as a result of a process interruption. **a** Rod with multiple layer shifts caused by several process interruptions. **b** PBF-LB/M printed bust of Athena with layer shift due to a process interruption

loss due to the machine downtime. If the build job is cancelled, there is also a waste of materials such as powder or shielding gas. Due to the interruption and the associated cooling and shrinkage of the components, a circumferential mark is created when the process is continued, which is referred in VDI 3405 Part 2.8 as a layer shift [12] (Fig. 1). If they are not removed by machining, the marks cause not only a visual flaw but also a notch effect which has a negative impact on the mechanical properties of the component. Due to the interruption and the associated cooling of the parts, the powder bed and the entire system, there is also a risk of reduced bonding between the areas before and after the interruption when the build job is continued. In addition, the machine and generated components are slowly heated up by the PBF-LB/M process at the start of a regular build job and then remain at a stable temperature level until the build job is completed. However, if the build job is resumed after an interruption of several hours, the machine and the components undergo repeated heating and cooling phases, which could affect the quality of the components. If the build chamber is opened during the interruption or if the system is not completely sealed, oxidation, humidity or contamination of the powder bed can cause additional problems.

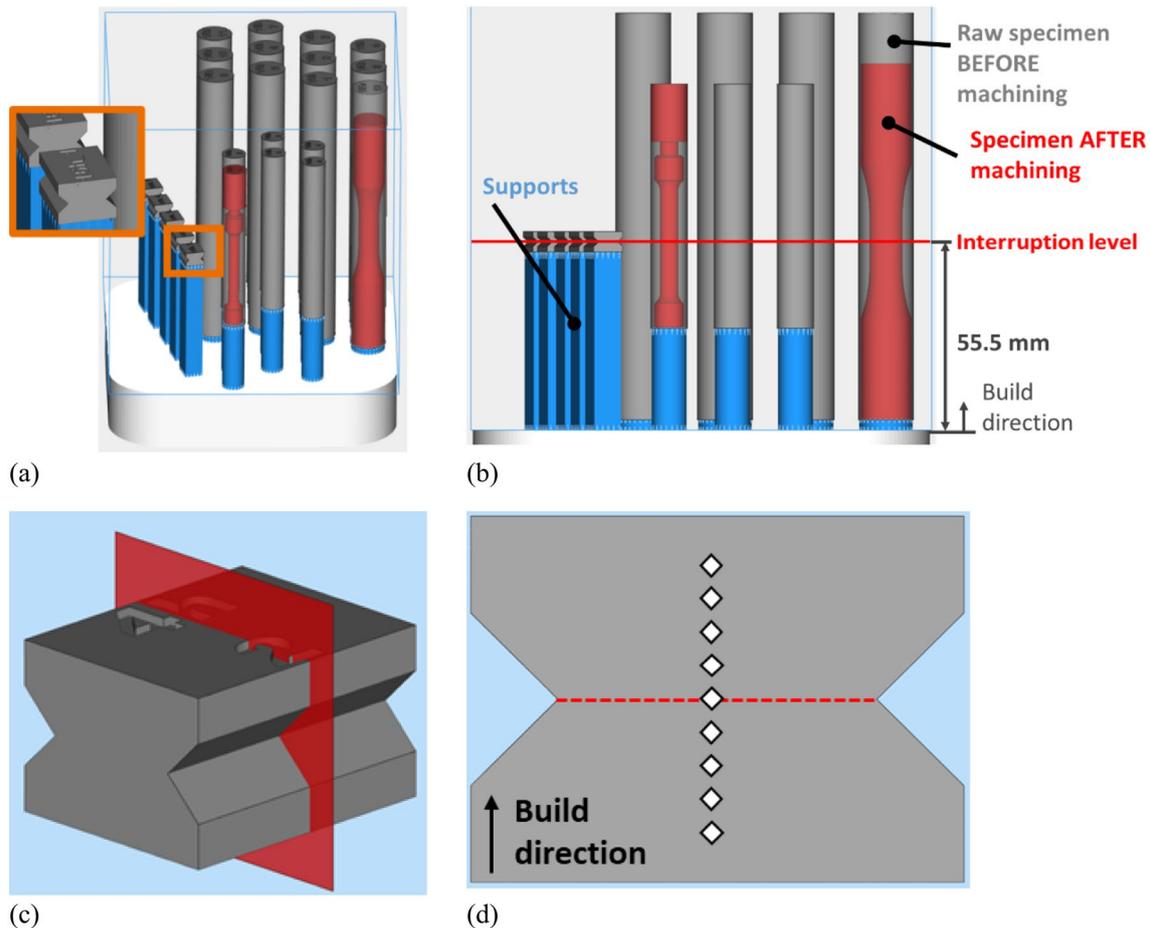
Fig. 2 Build layout with notched cubes, tensile and fatigue specimens (a), marking of the interruption level (b), ground plane of cubic specimens (c) and test pattern for HV 0.1 hardness test (d)

The notched cubic samples with dimensions 8 × 10 × 6 mm³ served three main purposes—examining the geometry of the layer shift and investigating the microstructure and hardness following DIN EN ISO 6507-1 [13] and VDI 3405 Part 2 [14]. The notch on these samples marked the interruption level, facilitating its identification in cross-sections. A Keyence VR-5200[®] 3D profilometer was used to measure the geometry of the layer shift. To prepare metallographic sections for hardness and microstructure analyses, the samples were ground and polished along the plane shown in Fig. 2c. Microstructure examination required additional etching of the samples with 5% sodium hydroxide

solution. Microscopic analysis was carried out using a digital microscope Keyence VHX-3000[®] and a Zeiss Ultra 55[®] SEM. For HV 0.1 hardness testing, a QATM QNESS 60 A + EVO[®] was used, producing the test pattern as shown in Fig. 2d. The red dashed line marks the interruption level on which one measurement was performed. Additionally, four more measurement points were placed above and below this plane, spaced at intervals of 0.5 mm.

The small grey cylinders depicted in Fig. 2a and b are tensile test specimens according to DIN 50125-B5 × 25 [15]. These specimens were initially produced as plain cylinders with a diameter of Ø10 × 72 mm³ and later machined by turning. Tensile tests were performed according to DIN EN ISO 6892-1 [16] using a ZwickRoell Z100/SN3A[®] machine. A Keyence VHX 3000[®] digital microscope and a Zeiss Ultra 55[®] SEM were used for fracture surface analysis.

For assessing fatigue resistance, specimens following DIN 50113 [17] (Ø15 × 72 mm³ and Ø15 × 120 mm³) were manufactured, as shown in the larger cylinders in Fig. 2a and b. There are two types of fatigue specimens—“as-built” specimens, which were 3D printed in their final shape, and “machined” specimens, initially shaped as Ø15 × 120 mm³ cylinders and then post-processed by turning. To evaluate time-dependent strength, the pearl string method following DIN 50100 [18] was used with $R = -1$, employing a Sincotec POWER ROTABEND[®] rotary bending test machine. Each stress level was tested at least twice. During the study, it became evident that the number of 12 fatigue specimens was insufficient for generating statistically significant results. Consequently, fatigue specimens were manufactured separately with a 10-h interruption, with each variant comprising 30 specimens. To avoid potential variations in temperature history affecting the specimens, the large cylinders, intended as fatigue specimens, were still printed within the layout shown in Fig. 2a. They were used for measuring the interruption marks and additional hardness tests. Five samples per interruption period were selected to measure the marks. For the hardness measurements, three samples with ten- and 16-h interruptions and the same number of reference samples were used. Like the cubic samples, these were first embedded and prepared by grinding and polishing. The hardness measurements were carried out on the same device and with the same settings as for the cubic specimens, but

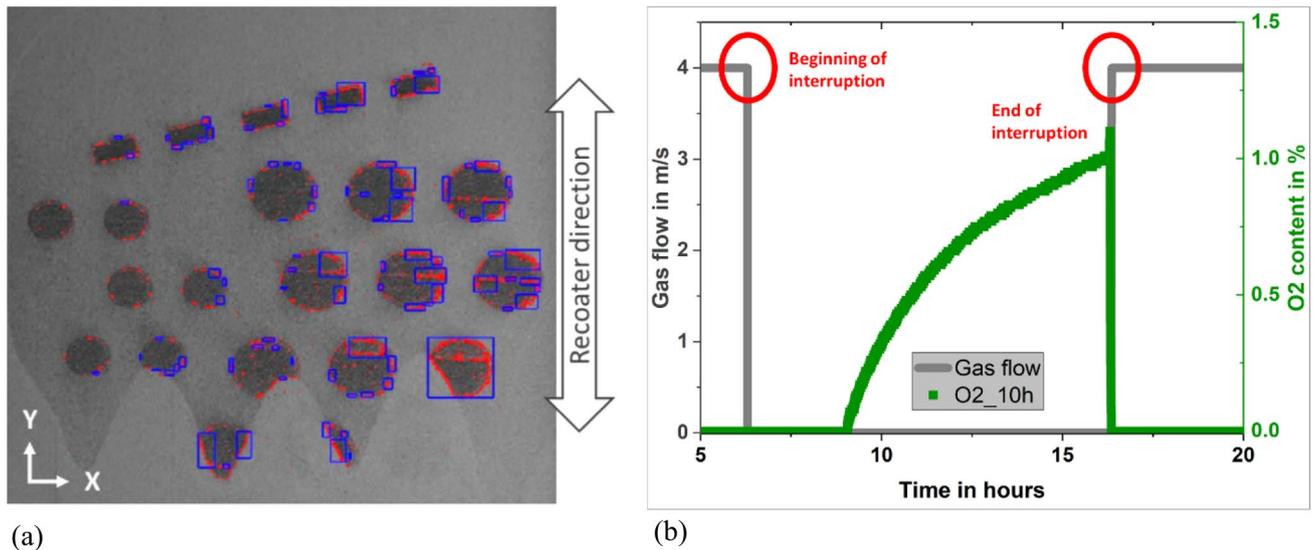
Fig. 3 **a** Image of the layer control system (LCS) installed in the SLM125[®] shows an inhomogeneous powder bed due to insufficient powder quantity during the recoating process. **b** Shielding gas flow velocity and oxygen content in the building chamber during a 10 h interruption

After the interruption and a 15-min preheating time, a manual recoating was carried out. It was observed that especially after longer breaks exceeding 10 h, a single recoating process is not sufficient to achieve a homogeneous powder layer on all samples. Figure 3a shows an image of the machine's internal layer control system (LCS). This system captures camera images of the powder bed and checks it for anomalies, which are highlighted in color. As can be seen, powder was only deposited in the lower area of the build plate, which means that the amount of applied powder in a regular recoating process is not sufficient to create a homogeneous powder bed across all components. This indicates that the samples and the powder bed are not entirely heated up to the temperature before the interruption, which means a smaller thermal expansion in build direction and therefore a gap between the last solidified layer before the interruption and

In addition to the described cooling of the machine during the interruption, it must be expected that the machine is not completely sealed. For this reason, there is a risk of an increase in the oxygen content in the build chamber during the interruption. Figure 3b shows the flow velocity of the shielding gas and the oxygen content at the ceiling of the build chamber during a production interruption of 10 h. The drop and the rise in the flow velocity mark the beginning and the end of the interruption. At the beginning of the interruption, the oxygen level initially remains constant at 0%. After a standstill period of approximately 2.7 h, the oxygen content slowly rises to a maximum value of 1%. By flooding with argon again and switching on the inert gas flow during the restart procedure, the oxygen content increases briefly to 1.1% and then drops to 0% again before the build job is resumed and remains at this level until the end of the build job. This curve indicates that the oxygen content continues to increase with longer interruption duration, which is not the case. A maximum oxygen content of 1.1% was also recorded for a 16-h interruption. In contrast, the oxygen content remains at 0% during an interruption of 1 h and rises to a maximum value of 0.6% after 4 h. This shows that the SLM125[®] is not completely leakproof. Possible explanations are not completely sealed system boundaries such as

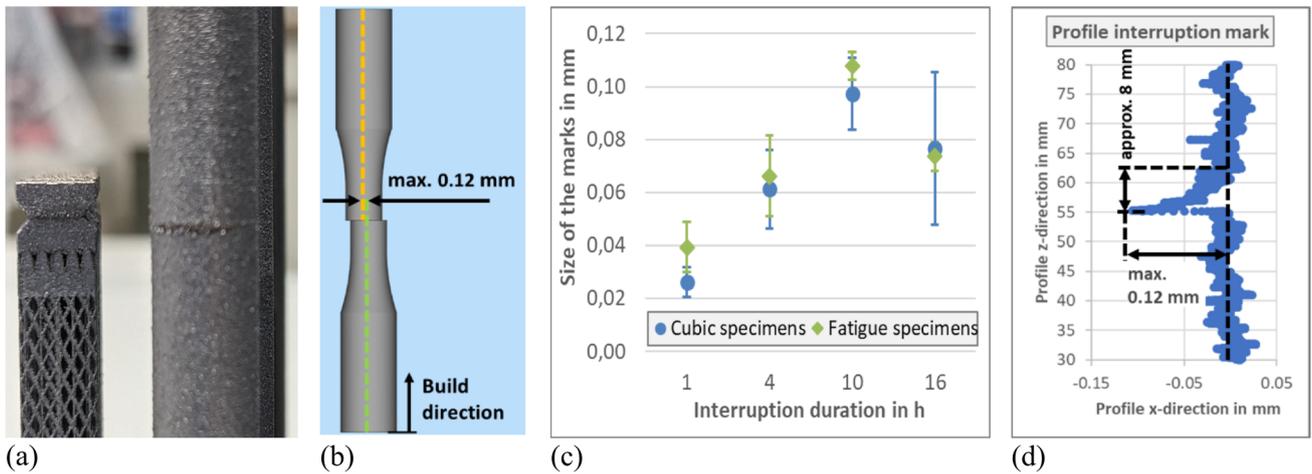
Fig. 4 Geometry of the layer shift. Layer shift on the real specimens (a), shift on the example fatigue specimen (b), size of the interruption marks depending on the interruption duration for cubic and fatigue

specimens (c) and profile of the layer shift on the example fatigue specimens (d)

As expected, the specimens also show the previously mentioned layer shift (Fig. 4a). If these marks are not removed by subsequent machining, they represent a visual flaw and result in a notch effect. Just by visual inspection of the cylindrical specimens, it is noticeable that the layer shift is not a uniform circumferential defect. Instead, it is an offset of the upper half of the specimens printed after the interruption (Fig. 4b). Figure 4c shows the size of the interruption marks at different interruption durations for the cubic and fatigue specimens. It can be seen that the marks have approximately the same size for both geometries. Furthermore, a clear trend can be seen up to an interruption duration of 10 h. The mean size of the marks is 0.03 mm for 1-h samples and 0.06 mm for 4-h samples. With an average of 0.1 mm and a maximum of 0.12 mm, the largest marks occurred at samples with a 10-h interruption, followed by an average size of almost 0.08 mm at 16 h. In addition, on all examined fatigue specimens it was observed that this does not appear to be a permanent shift. About 8 mm after continuing the build job, the two halves of the specimen converge again and the offset disappears (Fig. 4d). Since the cubic specimens were too small and the tensile specimens were not examined

The correlation between the size of the interruption marks and the interruption duration shown in Fig. 4c might also be caused by a positioning error due to the cooling of the machine, the laser optics, the components and the powder bed. As the duration of the interruption increases, these cool down more, which increases the temperature difference compared to before the interruption. The smaller the temperature difference when the build job is continued, the smaller the positioning error might be. It is not yet clear why the marks of the 16-h samples are smaller than those of the 10-h samples. However, it is assumed that the reason for this can also be found in different temperature profiles. In addition, a combination of several effects mentioned in this study, such as thermal lensing, contraction of the laser optics and an increased first powder layer thickness when continuing the build job, is conceivable.

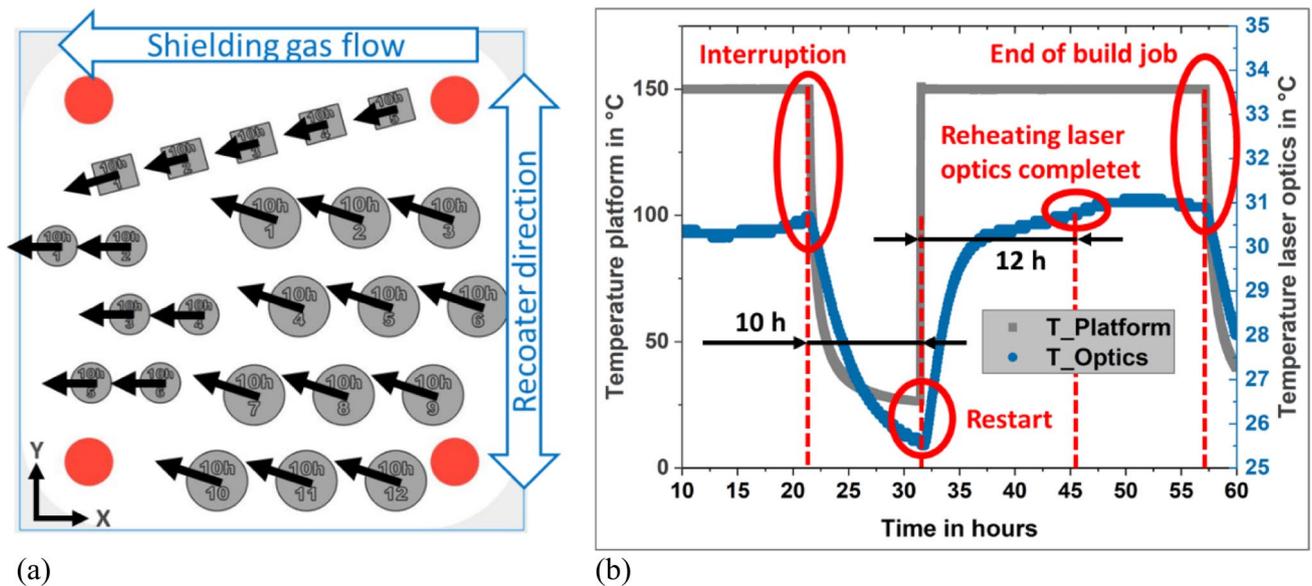
Fig. 5 Offset direction of the layer shift (a) and temperature history of the platform and the laser optics (b)

A more precise analysis of the layer shift reveals that there is a preferred orientation in negative x-direction (Fig. 5a). This phenomenon has occurred in all build jobs performed in this study, which strongly indicates a systematic effect.

Figure 5b compares the temperature curves recorded by sensors in the platform below the base plate and the optical bench of the machine. As can be seen, the platform and laser optics cool down from their operating temperature (platform = 150 °C; laser optics = 30.7 °C) to a temperature of about 26 °C within the interruption period of 10 h shown here. After the end of the interruption period, a restart procedure was carried out in which the base plate heating and the shielding gas flow were switched on again. While the platform reached the set temperature of 150 °C after about 3 min, the laser optics needed up to 12 h to achieve the same temperature as before the interruption. In addition, this behavior matches the results of the 3D scans on the fatigue samples in Fig. 4d, which show that the offset of the layer shift is not permanent, but is eliminated after about 8 mm. This will probably only happen when the temperature of the laser optics approaches the value before the interruption again and reaches a certain value. This temperature can be determined by calculating the production time until the misalignment disappears. With a layer thickness of 30 µm, 8 mm equals a number of 267 layers. An average layer duration of 31.8 s results in a production time of 2.36 h after continuing the build job until the mark has disappeared. At this time, the optical bench reaches a temperature of 28.3 °C, reducing the temperature difference from initially 4.7 °C to about 2.4 °C compared to the temperature before the interruption occurred. The temperature of the laser optics rises rapidly at first and then becomes flatter. This could explain why the offset is already compensated after about 2.36 h of runtime, instead of the expected 12 h. This also indicates that there is a positioning error in the first few layers at the start of every build job when the laser optics is still cold. These first layers usually consist of supports or are removed when the samples get cut from the build plate. Unfortunately, preheating the laser optics of a commercially available SLM125[®] is not

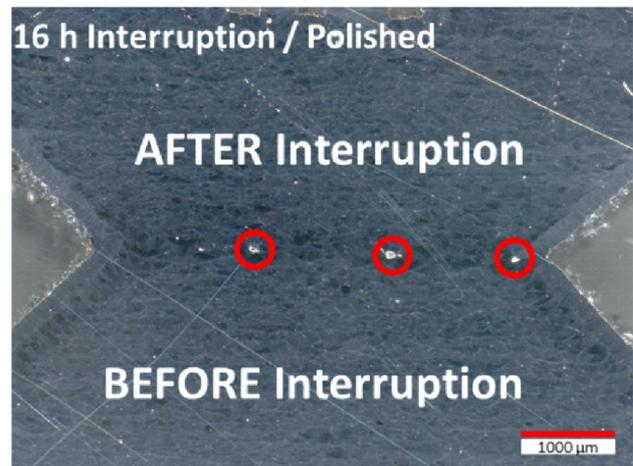
Fig. 6 Microscope images for analysis of porosity at a polished sample with a 16-h interruption

The results of the porosity investigations show that a distinct increase in porosity can only be recognized for the 16 h samples (Fig. 6). There is no significant change in porosity for all other investigated interruption times.

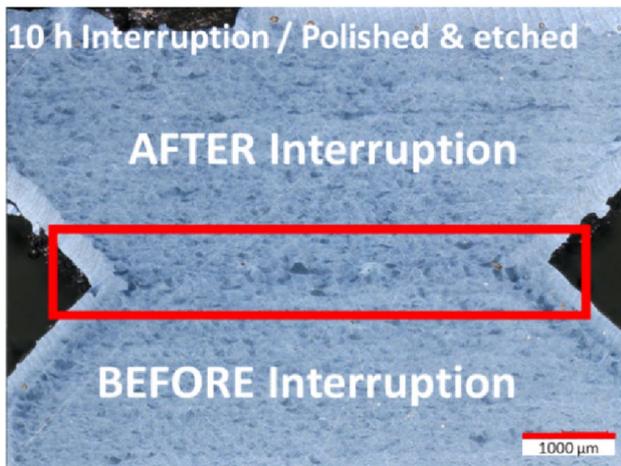
Fig. 7 Microscope images for analysis of microstructure of a polished and etched sample with a 10-h interruption

The first finding in the microstructure is a dark area in the interruption zone (red box in Fig. 7). This anomaly has also been observed in previous studies [5, 9, 10]. Binder et al. [5] opened the chamber during the interruption, which is why they may have suspected increased oxidation. According to Mahtabi et al. [10], who observed the dark area with open and closed build chamber, the changed temperature history due to the interruption could be responsible for this discoloration.

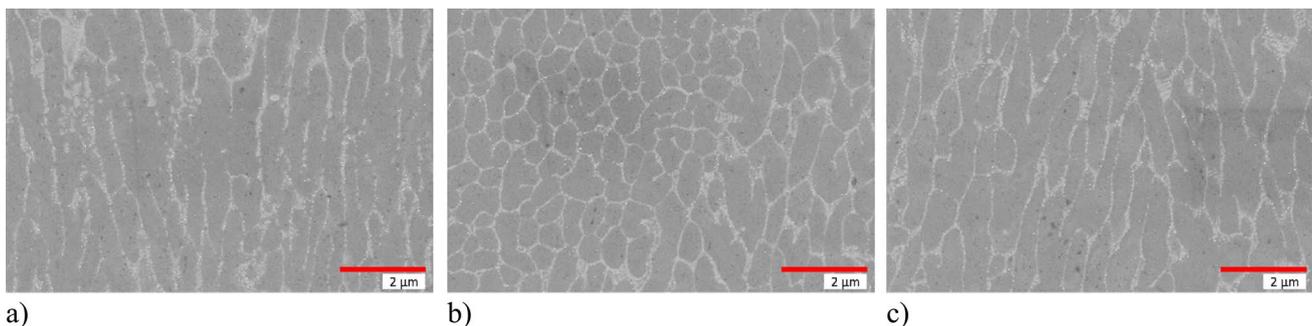
Fig. 8 SEM images 2 mm below (a), in (b) and 2 mm above (c) the interruption of a 10 h-sample

Figure 8 shows representative SEM images of the areas 2 mm below (a), in (b) and 2 mm above (c) the interruption of a 10 h-sample. It can be seen that the Al cells below and above the interruption have an elongated orientation in the build-up direction and are surrounded by a Si eutectic, also shown in the literature [6, 8, 9]. The grains preferably grow in the direction of the heat flow—in this case in the negative z-direction. Unlike in the areas before and after the interruption, the microstructure in the interruption area appears to have slightly more of the fine and round grain structures. This could indicate an interrupted or altered heat flow due to the process interruption and could also be a possible explanation for the discoloration in the interruption plane. However, this change is only a minor and localized effect. As already reported in several studies, no clear changes in the microstructure due to the interruption have been found within these investigations either [3, 6, 10, 11]. For this reason, the studies were limited to the reference and 10 h samples. The broken Si boundaries shown by Stokes et al. [9] and in Fig. 8a also occurred in the reference samples,

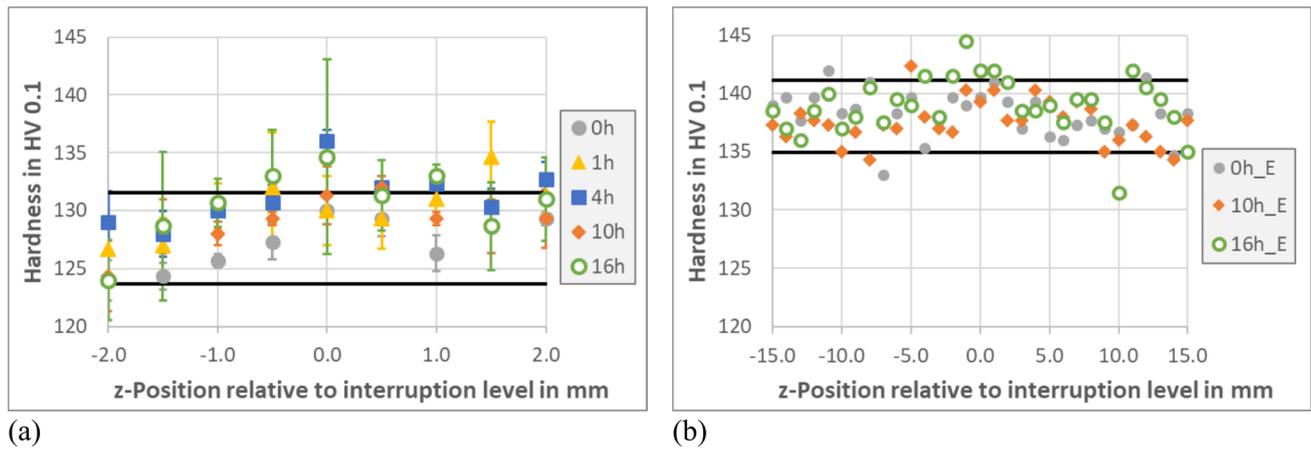
Fig. 9 Hardness profile of the cubic specimens (a) and the fatigue specimens (b) at different positions relative to the interruption level and interruption durations. The black horizontal lines represent the range of variation of the reference samples

Figure 9a shows the hardness values of the cubic samples at different z-positions relative to the interruption level for the investigated interruption times. The two horizontal black lines represent the range of variation based on the mean value and the standard deviation of the reference samples (128 ± 4 HV 0.1) and visualize the variance of the measurement results. The mean values and deviation ranges of all interruption times are shown in Table 2. For all interruption times, slightly increasing hardness values with increasing z-position can be recognized in the area below the interruption, which remain at a constant hardness level in the area after the interruption. For the 4 h and 16 h samples, the highest hardness values (136 ± 1 HV0.1 and 135 ± 8 HV0.1) were found at the interruption level. The reference samples show a similar trend of increasing and then constant values. In order to verify this trend over a greater build height, some of the fatigue samples shown in Fig. 2a and b, were used for this purpose. Figure 9b shows the hardness curves of the fatigue specimens for the investigated interruption durations. Compared to the cubic specimens, the hardness of the fatigue specimens is higher, as a different temperature history is present. Considering the small scatter band of the mean values and the relatively large standard deviations, no trends can be recognized depending on the z-position. As already observed for the cubic samples, the 16 h fatigue samples also show that the hardness values in the interruption level are slightly higher than in the rest of the sample. This could be due to the slightly finer grain structure shown in Fig. 8b. However, considering the large scatter of the values and the fact that almost all values are within the scatter band of the reference samples, the increased hardness values in the interruption zone might also be a coincidence.

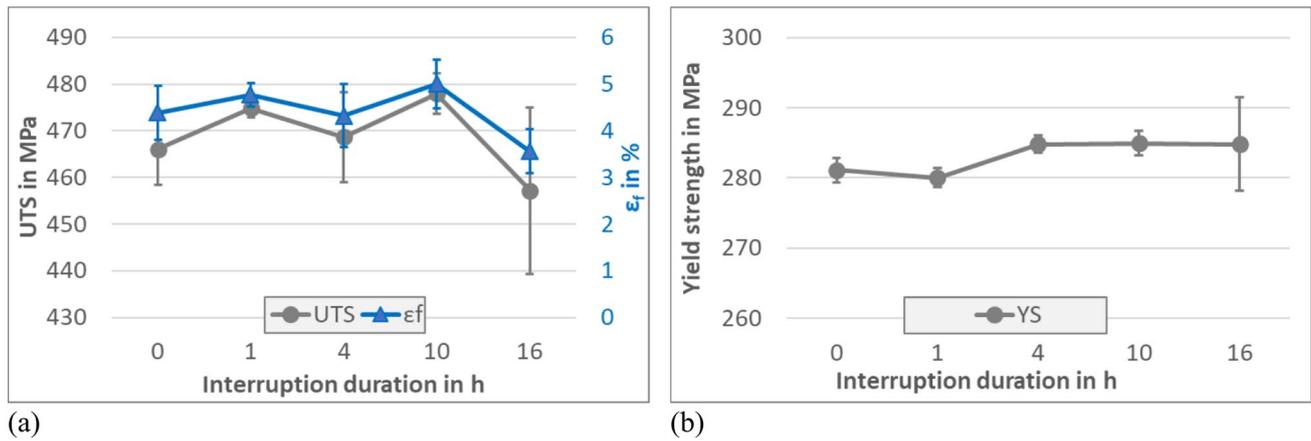
Fig. 10 Results of tensile tests: **a** elongation at break and ultimate tensile strength; **b** yield strength

The results of the tensile tests are also shown in Table 2 as well as Fig. 10. Again, an ANOVA was performed to provide a quantitative indication about the significance of the differences due to the interruption duration. The ultimate tensile strength (UTS) varies between 460 and 478 MPa depending on the duration of the interruption. A *p*-value of 0.015 indicates a significant influence of the interruption duration.

Looking at Fig. 10a, it is noticeable that UTS and ϵ_f show an almost parallel zig-zag pattern of increasing and decreasing values. This suggests a correlation between the two values, but this has not been mentioned in other studies. The yield strength, on the other hand, is not affected by an interruption lasting up to 10 h (Fig. 10b). In case of an interruption period of 16 h, there is a significant increase in the variation of tensile strength as well as yield strength. This indicates that the probability of critical defects such as lack of fusion (LoF) is significantly increased in case of a 16-h interruption, thereby reducing the robustness of the PBF-LB/M process. For unknown reasons, half of the reference specimens (0) as well as the 1-h specimens failed in the upper region outside the strain gauge extensometers. Even if the samples are broken in the cylindrical area of the specimens and the values can therefore be utilized, only the three samples that broke within the area of the extensometer were considered for the evaluation of the 0 h and 1 h interruptions. In Table 2, the values of all six samples are added in brackets.

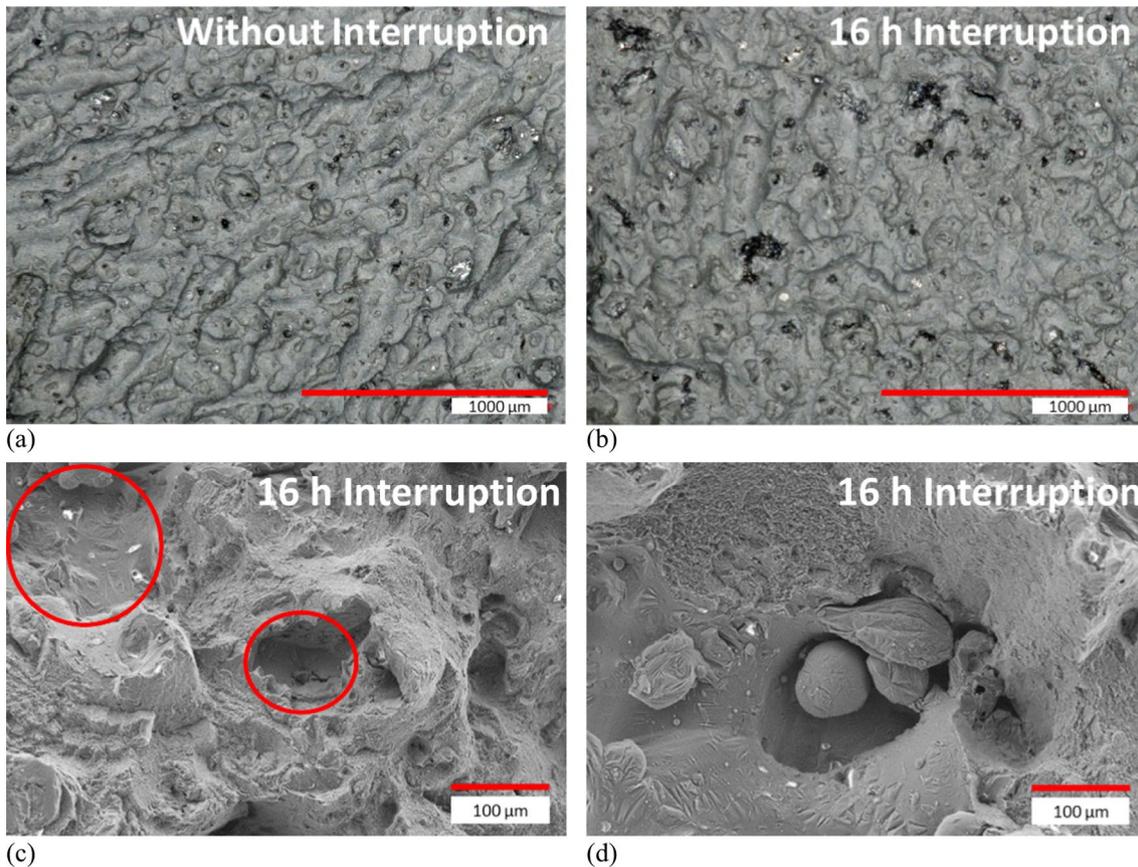
Fig. 11 Results of fracture surface analysis: **a** Digital microscope image of a fracture surface from a reference sample with less and small defects; **b** Digital microscope image of a fracture surface from

a 16-h sample with many LoF defects; **c** SEM images of flat surfaces; **d** SEM images of unmolten powder particles

Figure 11 shows examples of the fracture surfaces from a reference specimen (a) and a 16-h specimen (b). The digital microscope images show that with increasing interruption time, the proportion of defects that appear darker on the fracture surfaces increases. Figure 11c and d show SEM images of these defects. Flat surfaces (c) and unmolten powder particles (d) are a clear indication for lack of fusion (LoF). This supports the findings from the tensile tests that an interruption time of 16 h can have a negative effect on the mechanical properties.

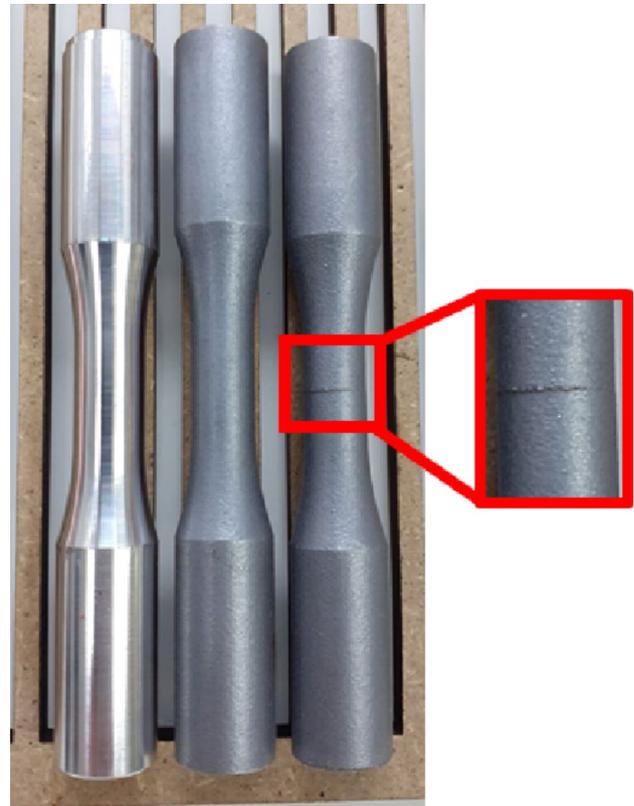
Fig. 12 Types of fatigue specimens: machined fatigue specimens (left), as-built specimens without interruption (center) and as-built specimens with a 10 h interruption (right)

In the context of this study, a distinction is made between two machining states of the fatigue specimens. These are as-built as well as machined specimens, which were produced without an interruption or with an interruption duration of 10 h. Three of the four types are shown in Fig. 12, while machined samples with and without interruption do not differ visually.

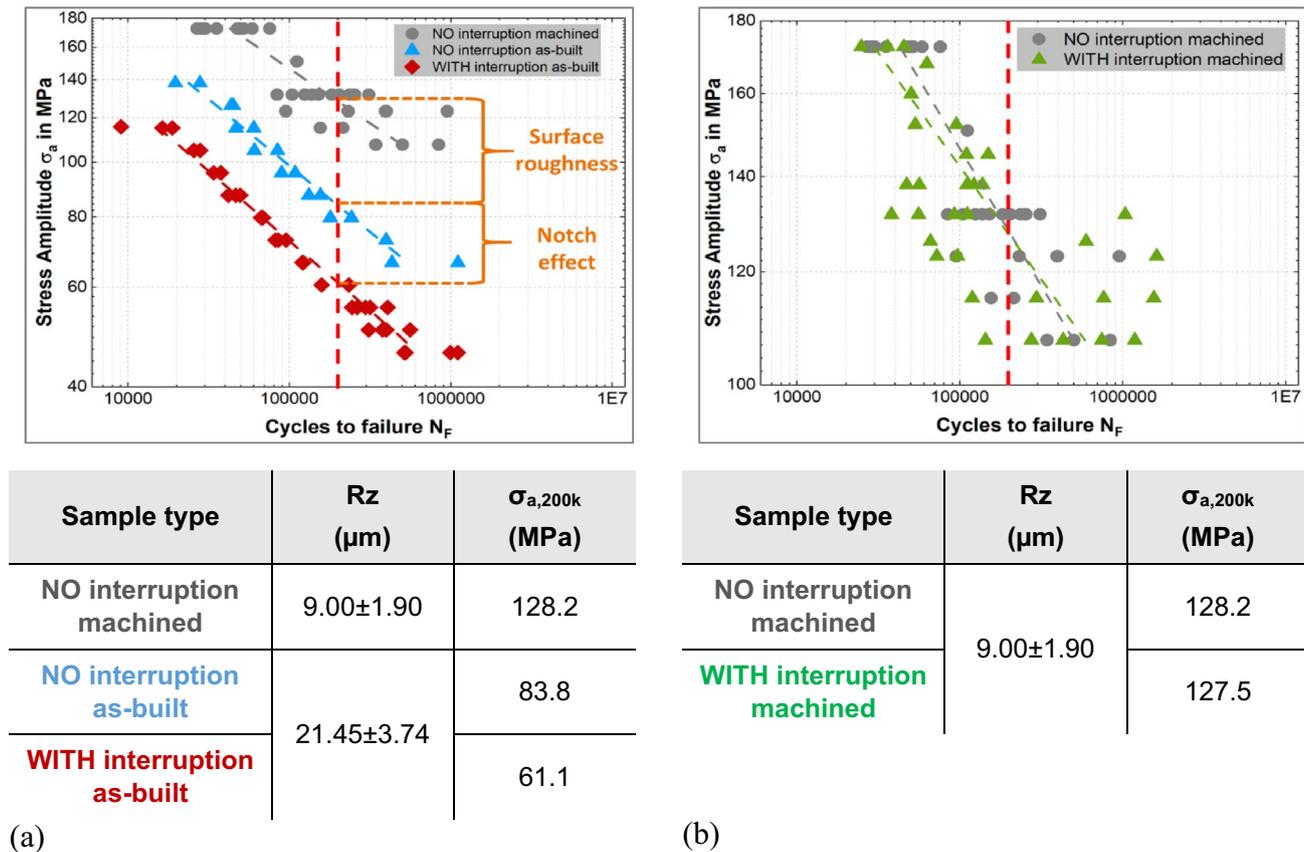
Fig. 13 Fatigue life diagram: **a** Comparison of as-built specimens without (blue) and with a 10-h interruption (red) with machined specimens without interruption (grey). **b** Machined specimens without (grey) and machined specimens with a 10-h interruption (green)

Figure 13 shows the fatigue life diagram in which the stress amplitude is plotted over the number of cycles to failure in a double logarithmic manner. Furthermore, the values for the mean roughness depth R_z as well as the theoretically endurable stress amplitude for 200 k cycles are shown. Comparing the properties of machined specimens without interruption (grey) with those of as-built specimens without interruption (blue), it can be seen that the as-built specimens fail significantly earlier (Fig. 13a). This can be explained by the higher roughness of the as-built specimens ($R_z = 21.45 \mu\text{m}$). The fatigue properties are mainly determined by surface near inhomogeneities and notches such as pores and the surface roughness [21–25]. This is also shown when comparing the as-built specimens

without interruption with those with interruption (red). The lower number of cycles to failure can be explained by the notch effect of the layer shift. The layer shift represents a single notch with a depth up to 0.12 mm and is thus about six times higher than the Rz. More surprising are the results of the machined specimens (Fig. 13b). Here, no significant difference can be seen between the specimens without (grey) and with interruption (green). It merely appears that the variance of the samples with interruptions is slightly higher. The results confirm the conclusions of Richter et al. (2021) [8] that the fatigue strength of machined specimens is not affected by a process interruption.
